Clifton Suspension Bridge - Cathodic Protection Case Study

Protection of Original Embedded Ironwork

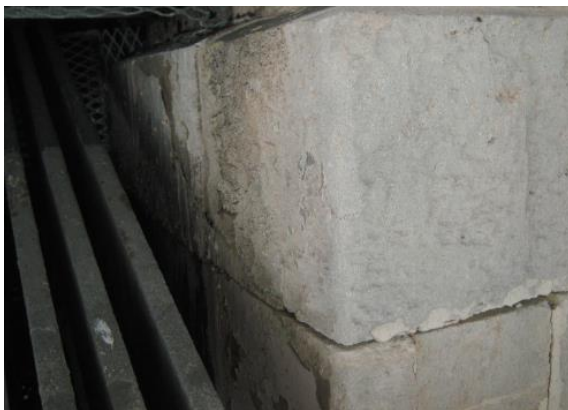
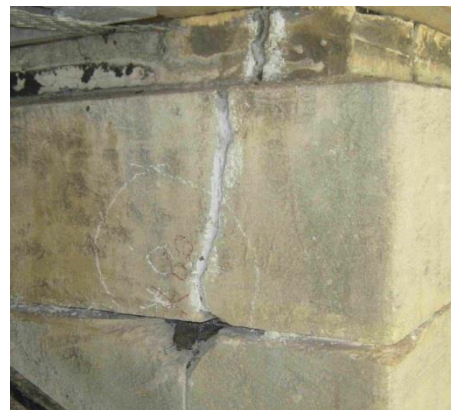
In 2015, Rowan Technologies was awarded a contract to install a CP system to inhibit further corrosion of the iron cramps and holding down bolts embedded in the stonework at the top of the two towers. Corrosion by-products are many times the volume of the original iron and it was these by-products that were causing both cracking and lifting of the stonework. Conservation policy requires that, as far as possible, the original structural materials be retained and cathodic protection was chosen to help prevent further damage caused by the original iron fittings.

Both Lifting of Stonework (Left) and Cracking (Right) are the Result of Corroding Embedded Ironwork

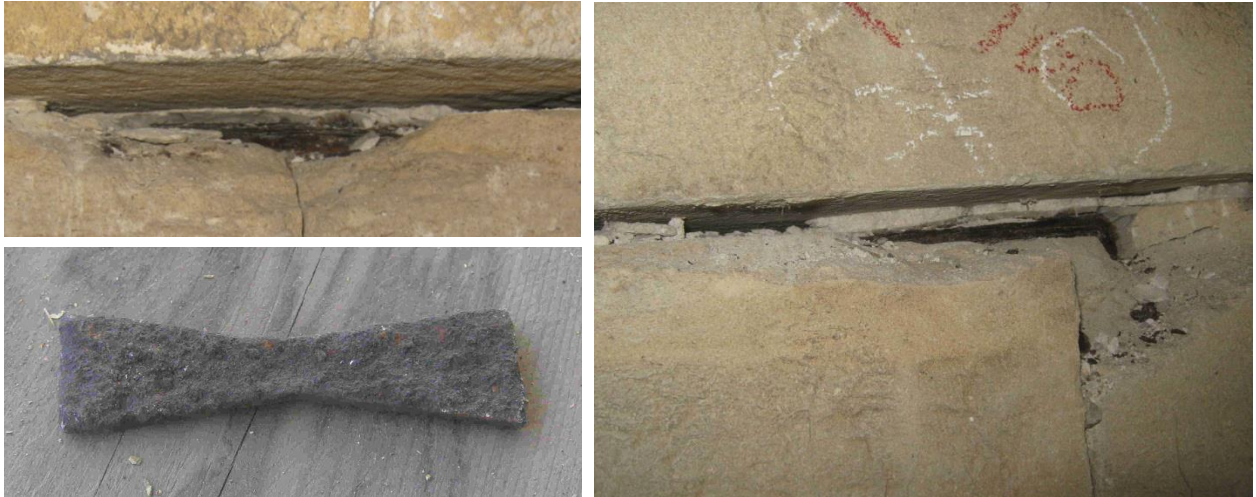
An initial survey of the ironwork involved a combination of different investigative techniques to identify and quantify the iron components within the stonework. Cramps were found to be of two kinds: so-called 'fishtail' and 'dog' cramps.

Fishtail (Left) and Dog Cramps (Right)

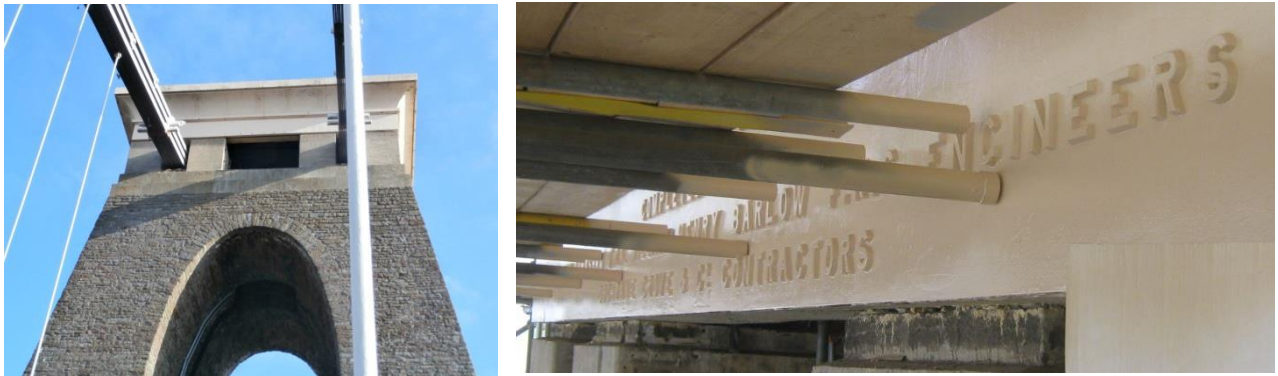
A total of 28 holding-down bolts were also identified, these held in place the two cast iron tower parapets, below:

The Cast Iron Parapets Sit Atop of Each Tower

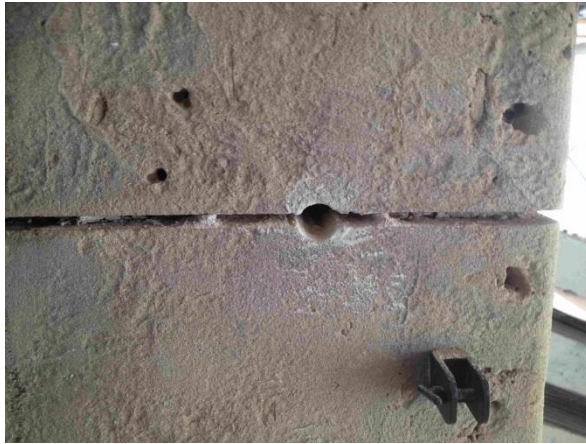
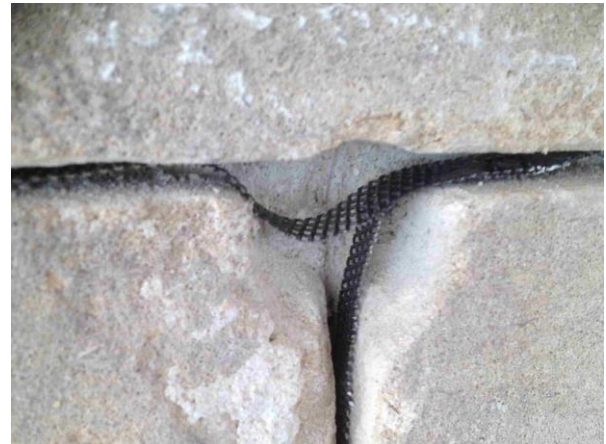
'Keyhole Surgery' is used to make Electrical Connections (Left). Anode Mesh Installation (Right)

The ICCP zones were designed using a system of mixed-metal oxide coated titanium ribbon anodes to protect the embedded iron components. The positive anode ribbon was installed as rings around the piers. The ribbon was inserted into opened-up joints which were subsequently repointed in using a cement/lime mortar. The completed piers were finished off with a shelter coating.

For the negative side of the circuit, 4mm self-tapping screws were used to fix a ring tag (and wire) to each individual section of wrought iron. Insulated copper wire was used to 'daisy chain' the individual sections of iron together.
