# Cathodic Protection of Embedded Iron in Church Towers

Dr David Farrell

Rowan Technologies Ltd, 216 Church Road, Urmston, Manchester  
M41 9DX, Tel: 0161-748-3644, Email: [mail@rowantechnologies.co.uk](mailto:mail@rowantechnologies.co.uk)

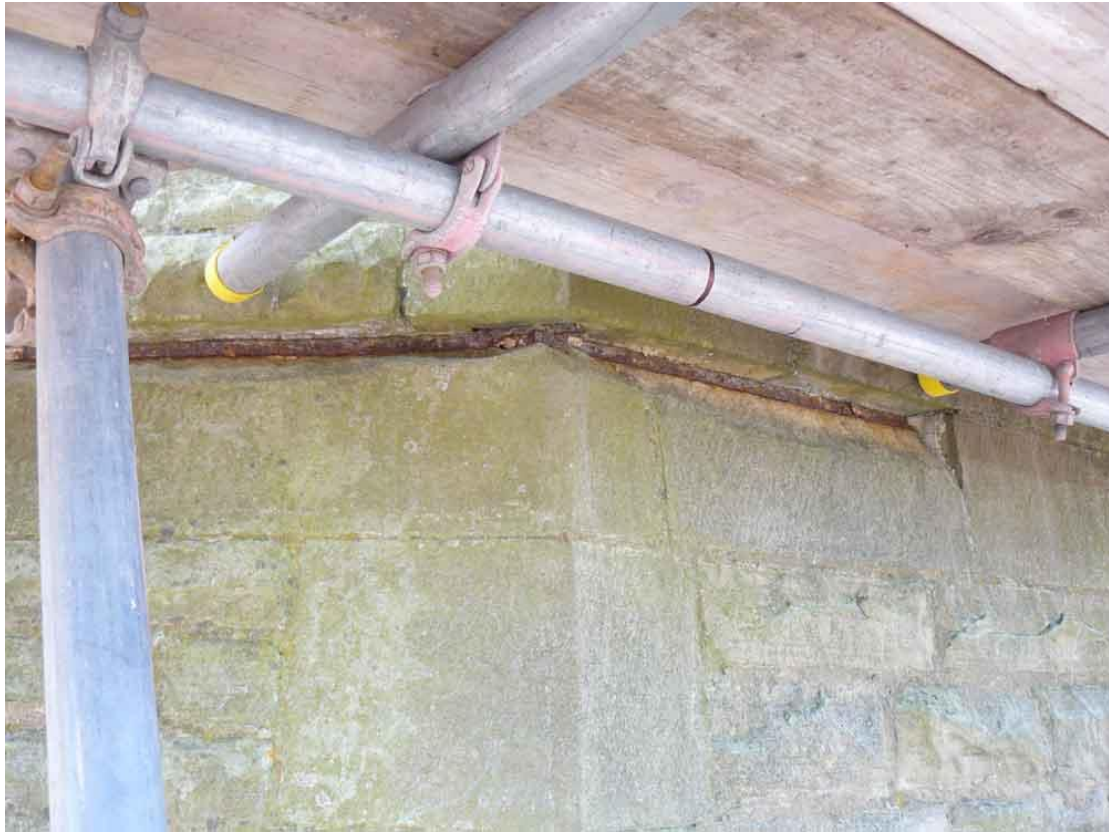
Figure 1 Tie bars embedded in the outer masonry and judged to be too disruptive to remove, St Mary's church, Balderstone.

Examples of corroding iron tie bars, which are connected together to form ring beams around church towers, are shown in Figures 1 and 2. Both these examples show spalling of the stones. Ring beams were originally incorporated into the towers to resist the masonry buckling outwards and to strengthen the walls to resist wind loading. Normally they are embedded within the external masonry to maximise

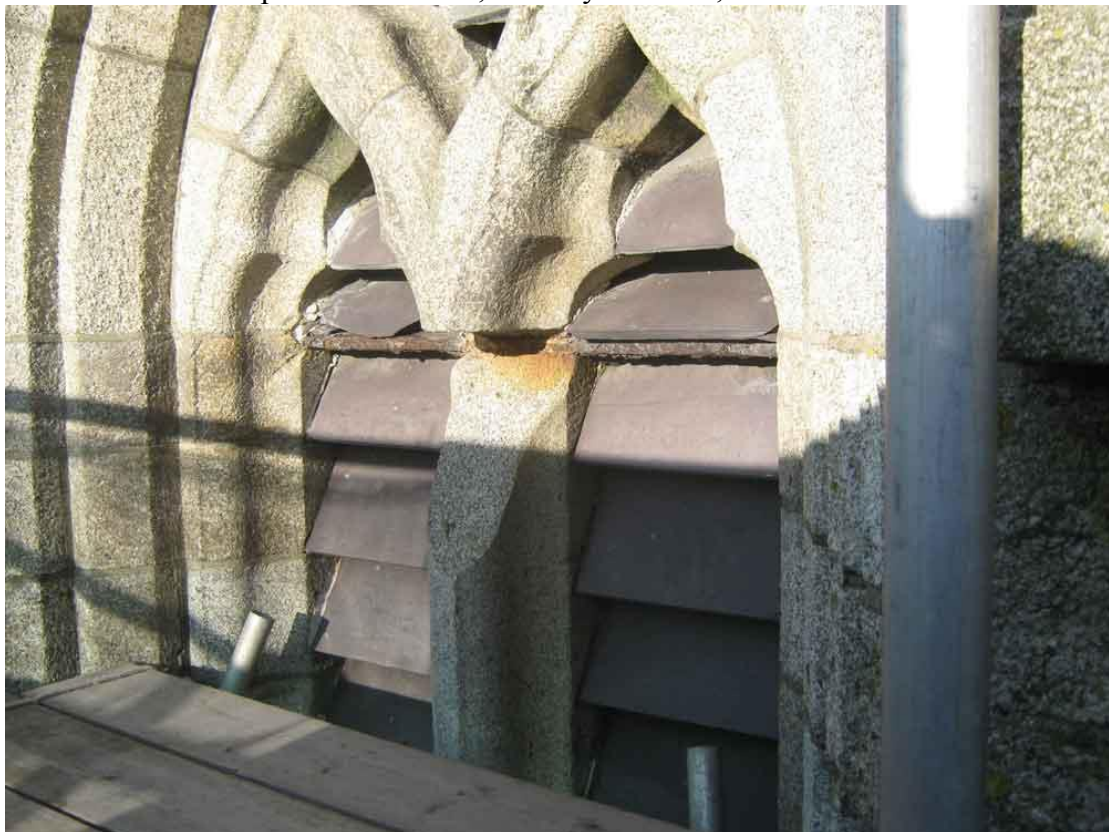
Figure 2 Large tie bars embedded in the inner masonry and passing through the mullions, resulting in fracture of the granite, St Aidan's Cathedral, Enniscorthy.

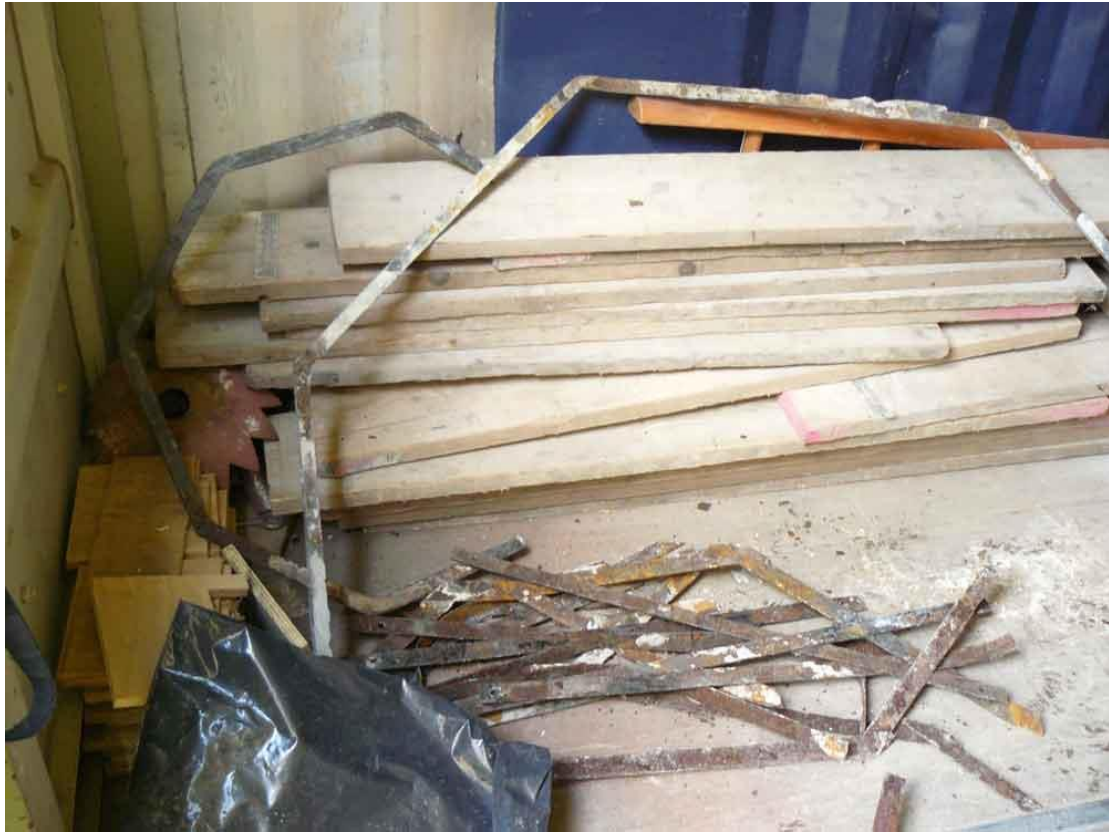
Figure 3 Corroding wrought iron fittings, which were readily removed from the tower, St Mary's church, Balderstone.

The conventional remedy has usually involved surgery to remove the iron fittings and cramps, Figure 3. They may sometimes be replaced with non-corroding phosphor bronze or stainless steel, or even left without replacement, prior to repair to the stonework. Conventional treatments can sometimes be highly invasive involving large-scale opening up to expose and treat affected components or even demolition to replace the iron. Cathodic protection offers a non-intrusive, alternative approach to the treatment of rusting iron embedded in masonry and stone.

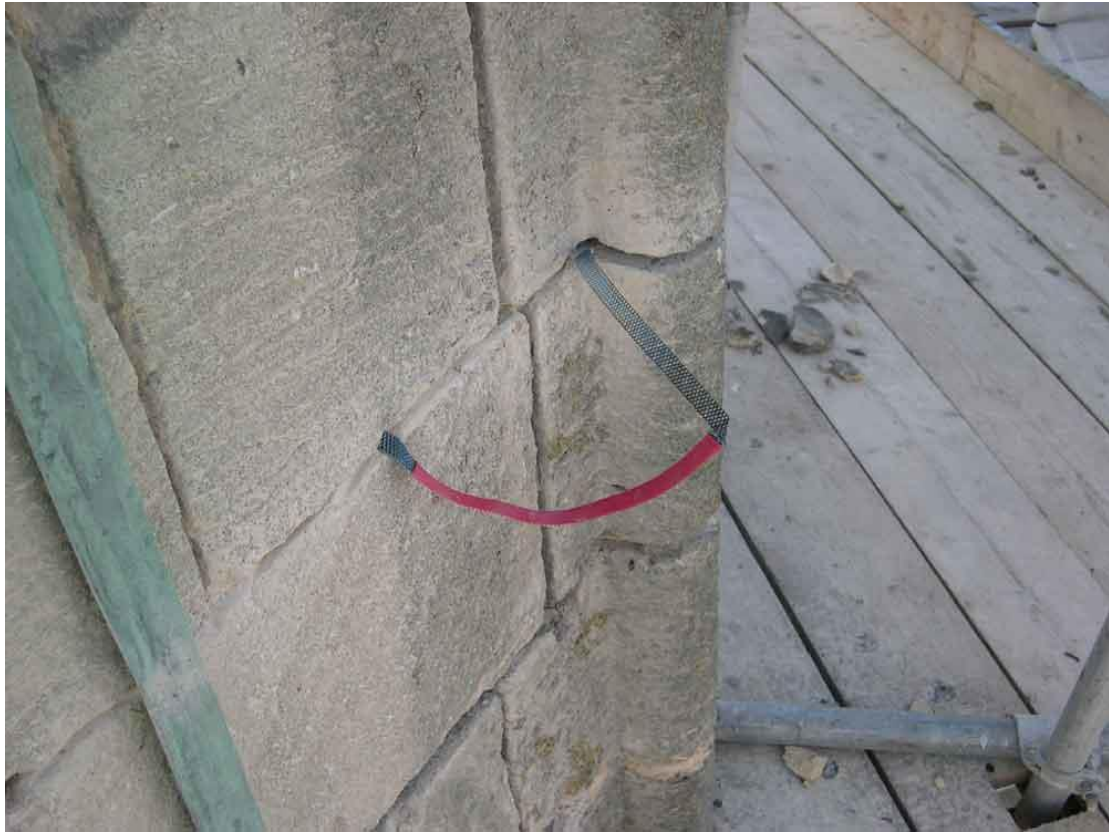
Figure 5 Anode ribbon being installed externally above and below the wrought iron to provide cathodic protection, St Mary's church, Kiddlington.

The 'positive' side of the CP circuit is formed by the anode ribbon, which should be installed equidistantly above and below the tie bars or ring beam. If the ring beams are fitted externally then the anode ribbon should also be fitted in the external joints, Figure 5. This has the added benefit that the external faces of the stones normally have higher moisture contents, as compared to the inner faces, and their electrical resistance will therefore be lower, requiring a decreased driving potential. Sometimes the ring beams are mounted internally and this may require internal scaffolding, or possibly working with rope access specialists, to install the system, Figure 6 and 7.

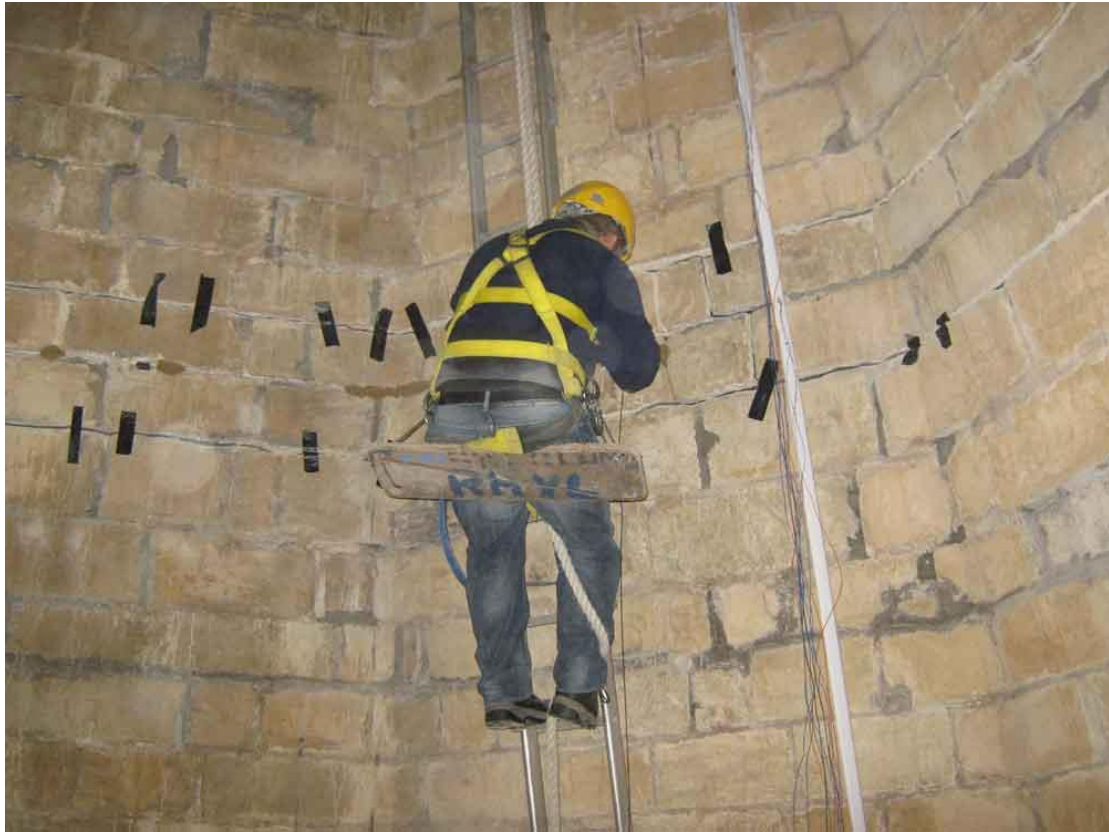
Figure 7 Anode ribbon being installed internally either side of the ring beams using rope access, St Aldhelms church, Doulting.

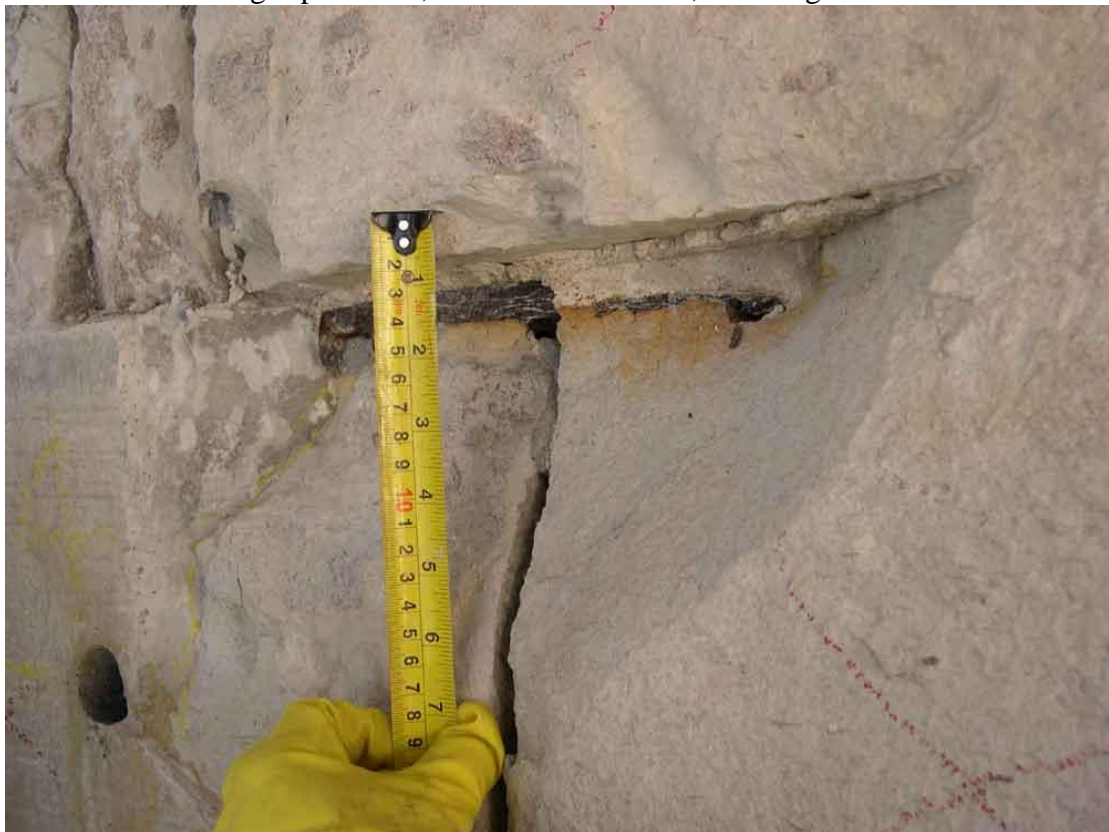
Figure 8 Internal damage to the stones due to corrosion of an iron cramp, St Michael and All Angel's church, Great Witley.

Wrought iron cramps are commonly found between stones in many church towers. Corrosion of the cramps results in expansion and cracking of the stones, Figure 8. If the situation is left unchecked, rainwater may have direct access to the iron cramps and the rate of corrosion increases, Figure 9.

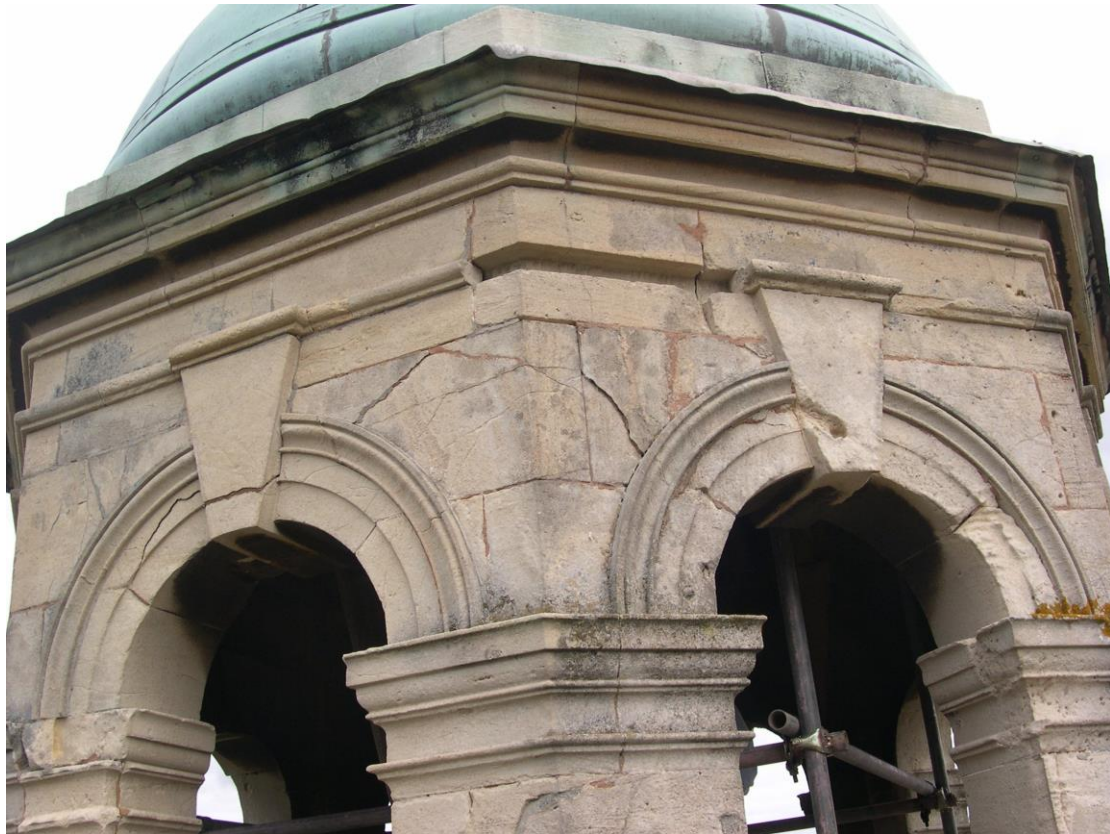
Figure 9 External damage to the tower due to corrosion of iron cramps, St Michael and All Angel's church, Great Witley.

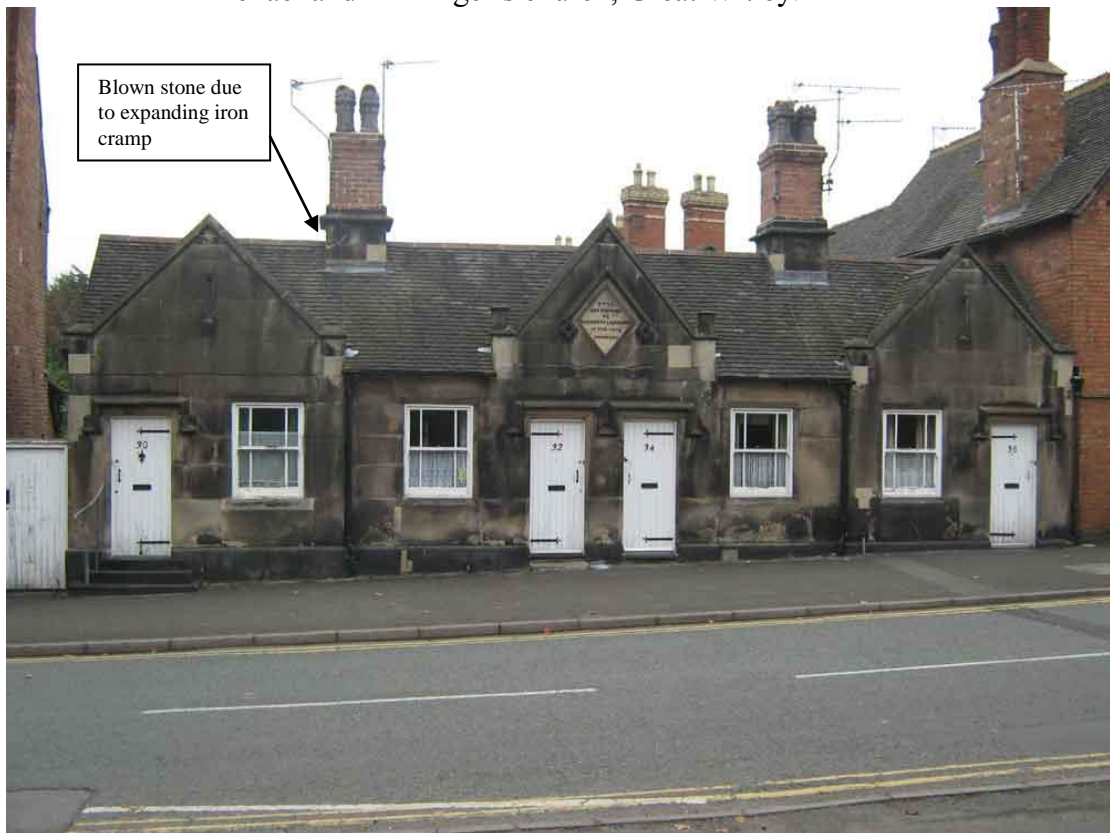
Figure 10 Whitchurch Almshouses ten years after the installation of cathodic protection – showing an unprotected cramp on the chimney has now fractured the stone.

The cottages were inspected in 2009, ten years after installation, and a visual assessment showed no spalling or iron staining where CP had protected the cramps. However, a stray cramp within the chimney, which had not been detected in 1999 and which had been omitted from the SACP system, had continued to corrode and blown the stone, Figure 10.
