## ***New Windows into Boiler Wall Health and Performance using Non-Intrusive Scanner Technology***

Bernard Robbins, Rowan Technologies Ltd (UK)

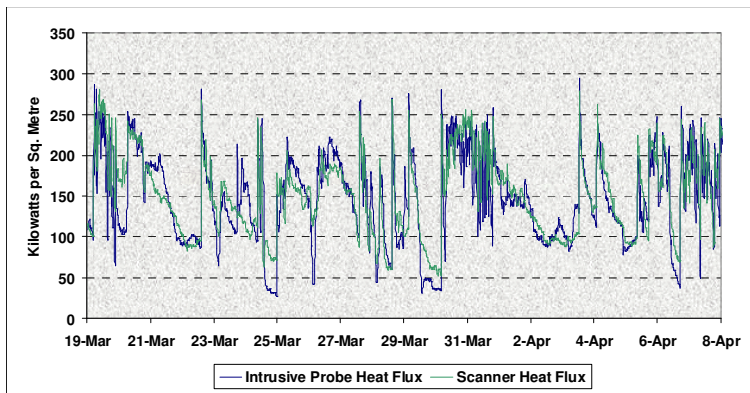
Figure 3: Comparison of scanner and intrusive probe heat flux data acquired some four tubes apart

The scanner's thermal data, besides helping to quantify tube wall corrosion, was also shown in the early Drax trials to predict good estimates of tube wall heat flux and fireside tube temperatures, as confirmed by intrusive heat flux probes installed in the same area of wall, Figure 3. Because the scanner sensors are laid out in rectangular matrices, this enables complete two-dimensional maps of the tube wall's fireside thermal conditions to be produced in real time, a feature which has been further developed in later system designs.

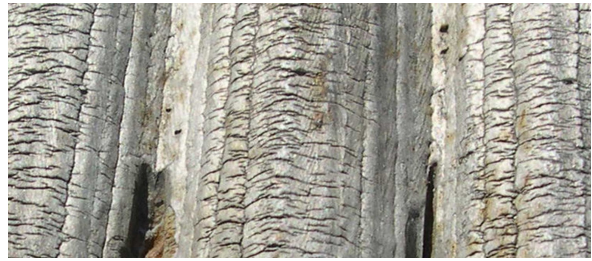
Figure 4: Fireside circumferential cracking of weld overlaid tubing

Brunner Island Unit 3 is an 800MW coal-fired supercritical unit. Like many supercritical units, the boiler is prone to circumferential cracking of the fireside tube walls under particular operating regimes, Figure 4. Plant modifications to reduce NOx emissions, together with the introduction of tube weld overlay to inhibit corrosion, have resulted in a greater prevalence of this type of cracking. Wall cracking is thought to have a number of causal factors including high wall temperatures, large tube wall temperature differences and corrosion fatigue.

Although cracks are initially superficial in nature, severe cracking of the tube walls at Brunner Island has resulted in a number of tube leaks and subsequent unscheduled shut downs for repair.
